### Crossing or Overtaking ?

## Rules of the Road – Situation #1

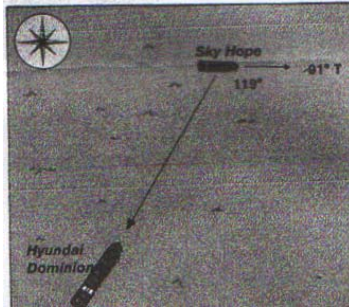
**Fig. # 1:** *Hyundai Dominion detected Sky Hope on a relative bearing of 45 to port at a distance of more than 5 miles and concluded that Hyundai Dominion was the stand-on vessel in a crossing situation.*

*Hyundai Dominion* (997 feet, 74,373 Gt.) was proceeding on a course of 036° T at 22 knots when its crew detected *Sky Hope* at 351 ° T (45° to port) at a distance of more than 5 miles. *Hyundai Dominion* took no action, since the bridge watch believed their ship to be the stand-on vessel in a crossing situation.

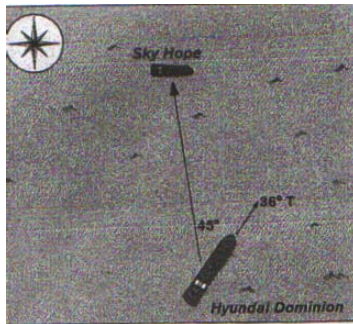
**Fig. #2:** *Sky Hope reported detecting Hyundai Dominion 119' off its starboard quarter at a distance of 6 miles and concluded that Sky Hope was the stand-on vessel in an overtaking situation.*

a bearing of 210° T (119° relative) 6 miles off her starboard quarter. No action was taken by *Sky Hope*, as the crew interpreted the ship's status as stand-on in an overtaking situation.

One factor highlighted by the investigation was that of a probable bearing error (or misinterpretation of the bearing) on the part of *Sky Hope*, leading to the erroneous conclusion that *Hyundai Dominion* was overtaking rather than crossing.

A direction-of-relative-motion plot showed the bearing of *Hyundai Dominion* from *Sky Hope* would have to have been approximately 173° T (082° relative) rather than the reported 210° T (119° relative), thus placing *Sky Hope* as the vessel approaching *Hyundai Dominion*, rather than *Hyundai Dominion*, approaching *Sky Hope* from starboard and overtaking.
